# COUPLE6 ALIGNMENT REPORT

Machine Name            MOTOR PUMP 132KW. CDP-2  
Company Name            Amita (Thailand)  
Location  
Address

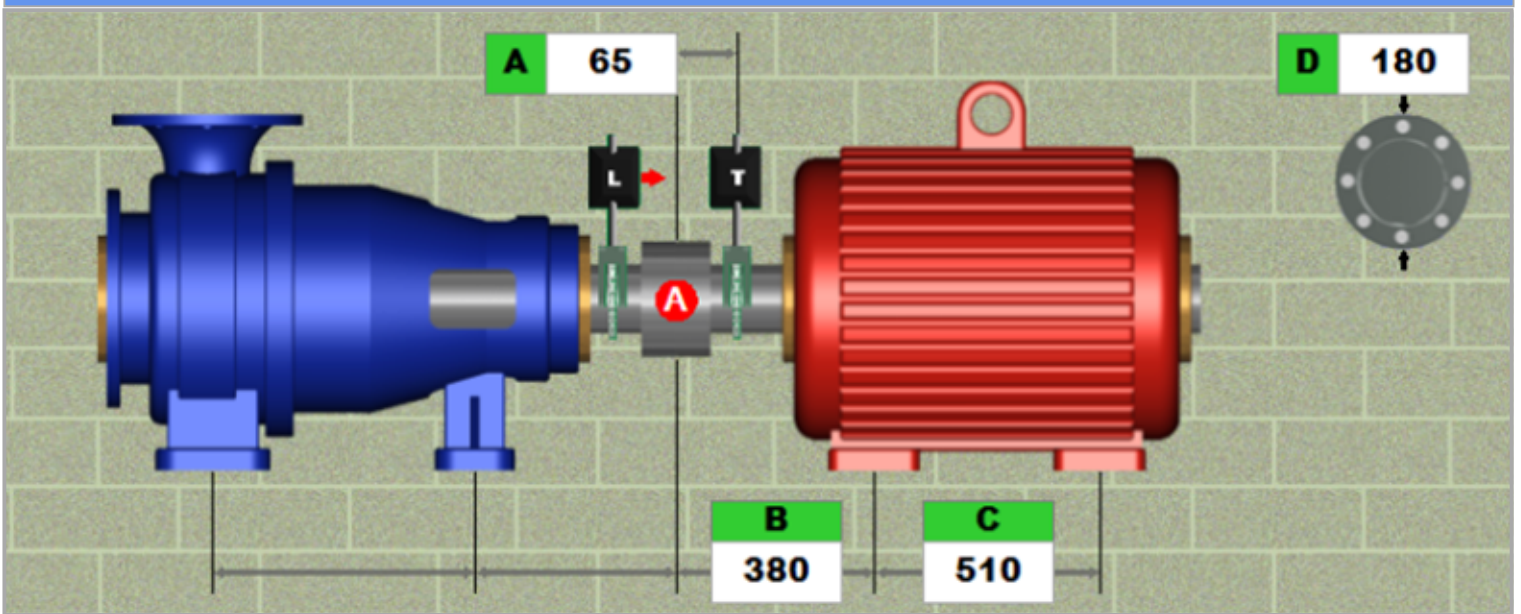
## MACHINE SETUP

OFFSET = mm, ANGLE = mm/100mm

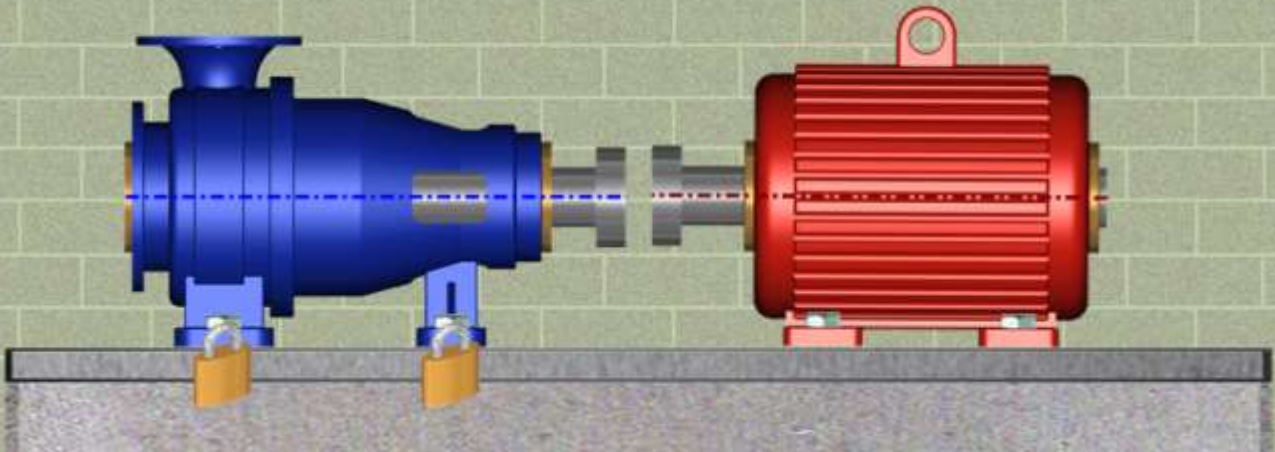
## SIDE VIEW / VERT.

**GAP**

**-0.01**

RPM	TOLERANCES	
	ACCE...	EXCEL...
1200+		
OFFSET	0.10	0.06
ANGLE	0.08	0.05
GAP	0.14	0.09

**OFFSET**

**0.02**

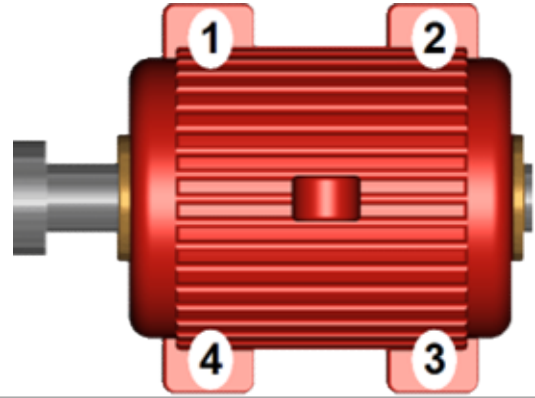
# SOFT FOOT

FOOT	TIGHT	LOOSE	CHAN...	NOTES
1	---	---	---	N/A
2	---	---	---	N/A
3	---	---	---	N/A
4	---	---	---	N/A
